DGCouplings

Dry Gas Couplings

Service Instruction

3" Tank Unit

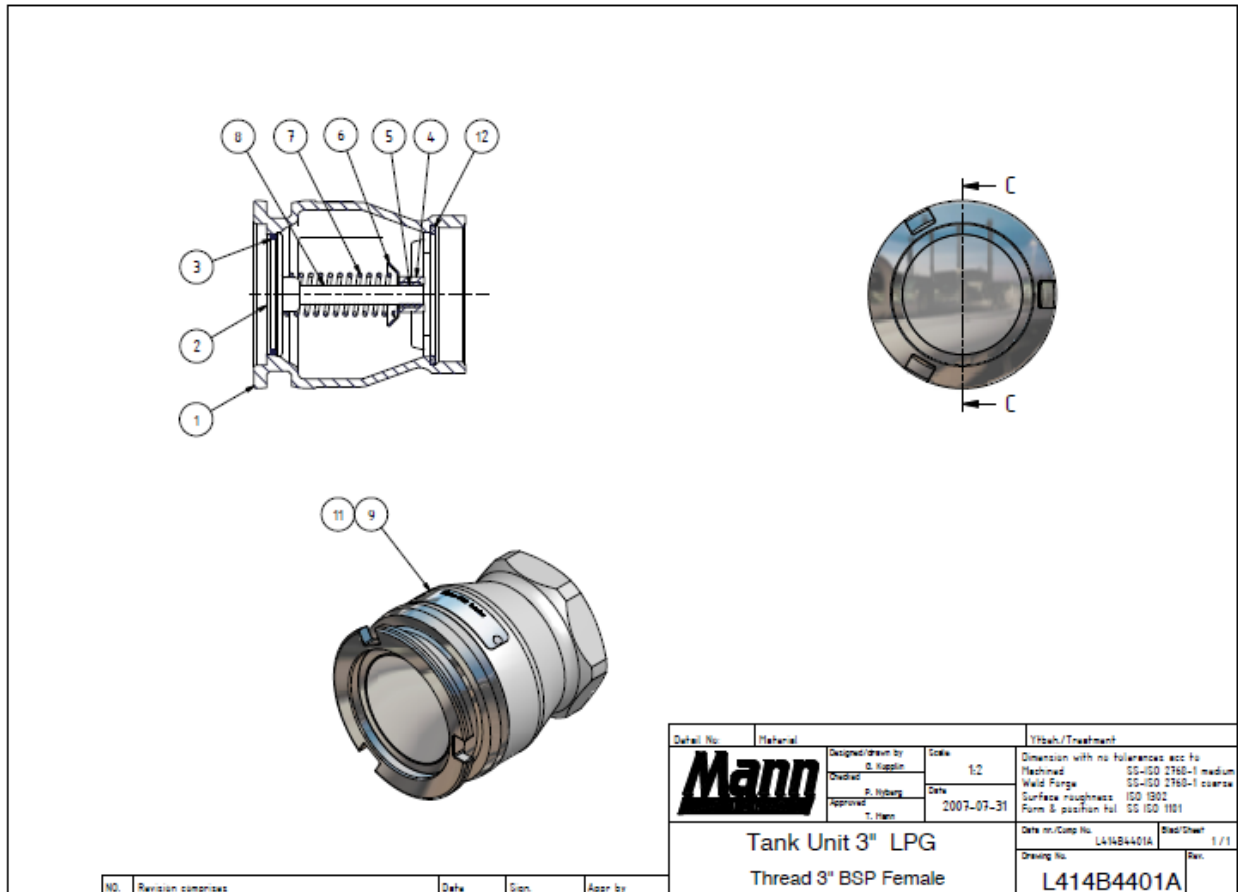
TANK UNIT 3"

Material: Al, SS

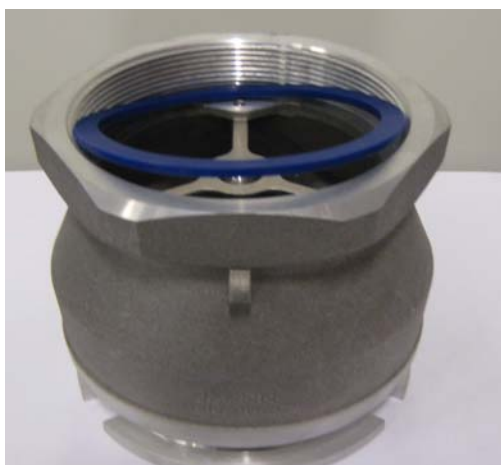
Remove the flat sealing.

NPT-thread doesn't have a flat sealing.

Make sure you don't scratch the seal face.

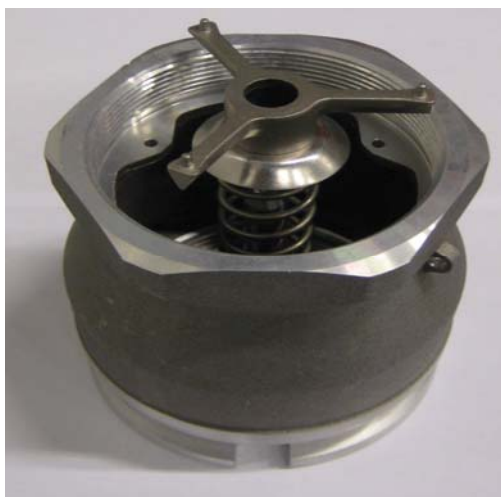
Press down the spindle steering and turn it free.

Take out all the parts from the body (spindle steering, spring cap, spring).

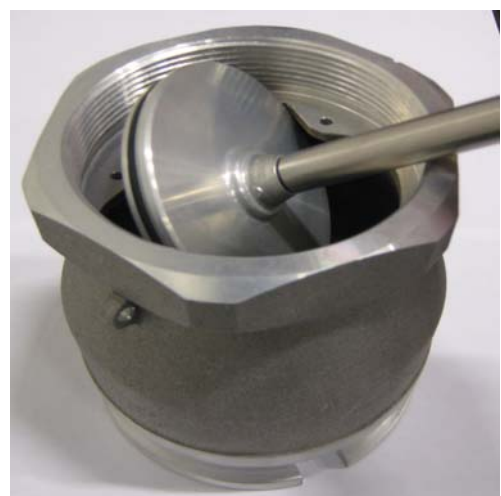
To take out the piston put into a relaxing position in the valve seat.

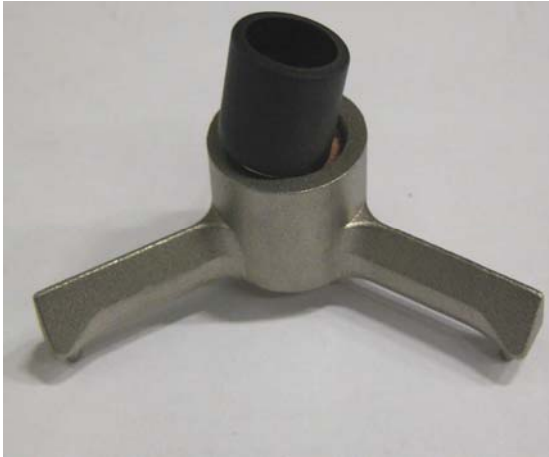
Replace the Teflon® bushing (pos.5) in the spindle steering with a new one.

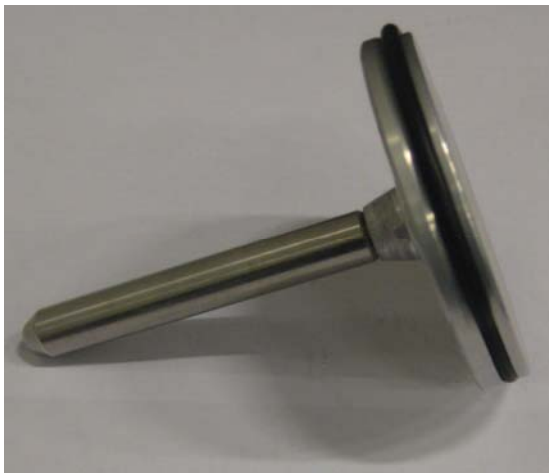
Replace the O-ring (pos.3) on the piston with a new greased O-ring.

Have an equal pressure around the O-ring. The O-ring must be pressed into the groove in the piston.

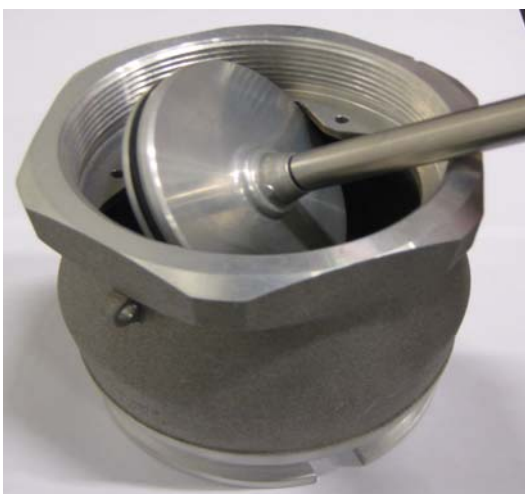
To insert the piston back again it should be putted in a relaxing position in the valve seat

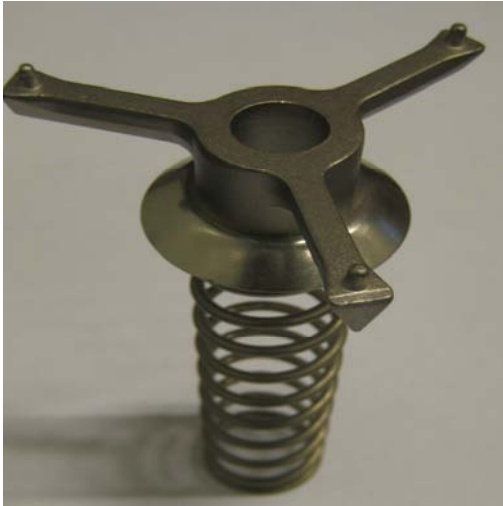
Replace the spring (pos.7), spring cap (pos.6) and the spindle steering (pos.4).

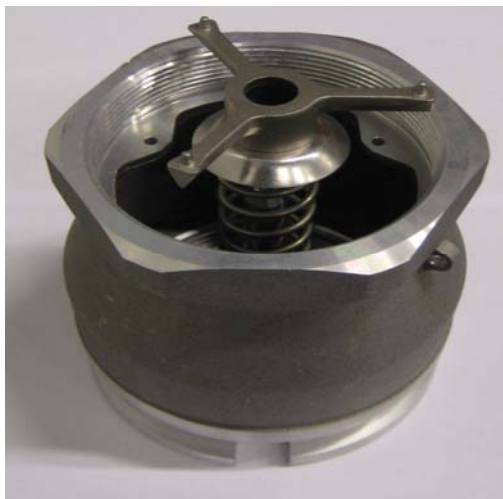
Press down the spindle steering and turn, to fix it in its position.

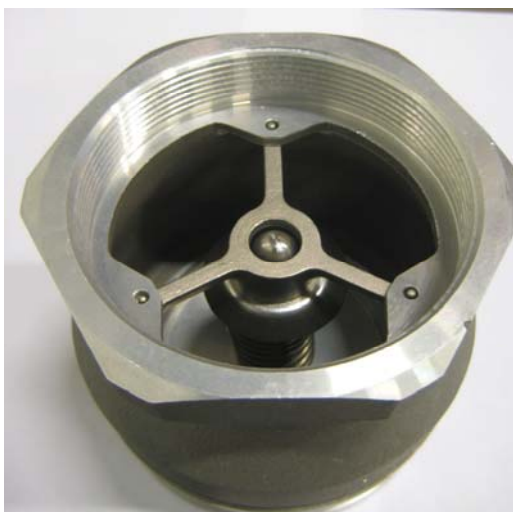
Make sure that the spindle steering is in it's right position.

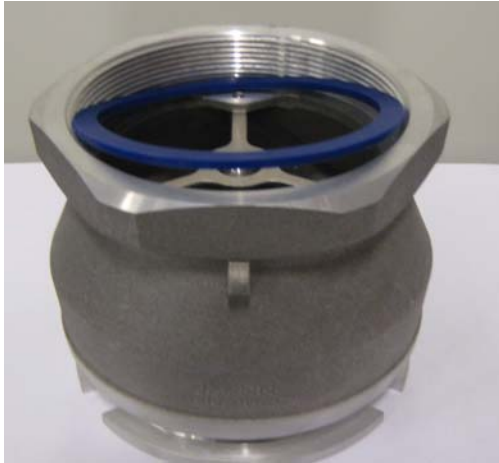
Assemble a new flat sealing (pos.12).

NPT-thread does not have a flat sealing.

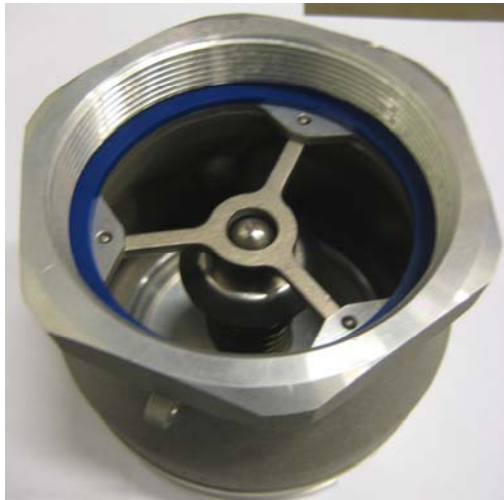
Finally, make a visual inspection that everything is in its right place. Do also a test connection/disconnection with a hose unit that not is mounted and not has any fluid inside. If the coupling works all right you are ready to use it again.
